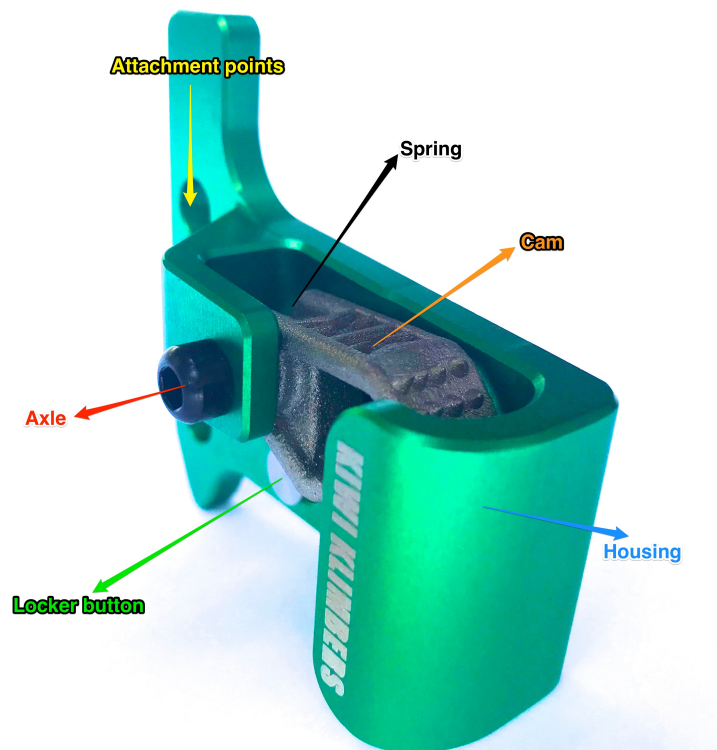
Spikesender, Spacer & Gaffs –

Attachment points: Bolts are tight, spikesender has not shifted, look for fractures.

Spring, Axle & Cam: are operational free from debris

Housing: Is not fractured, different from its original shape or excessively worn.

Gaffs: Have not moved, not fractured / bent, different from original shape or excessively worn.

If any part doesn't pass a visual and physical inspection discontinue use

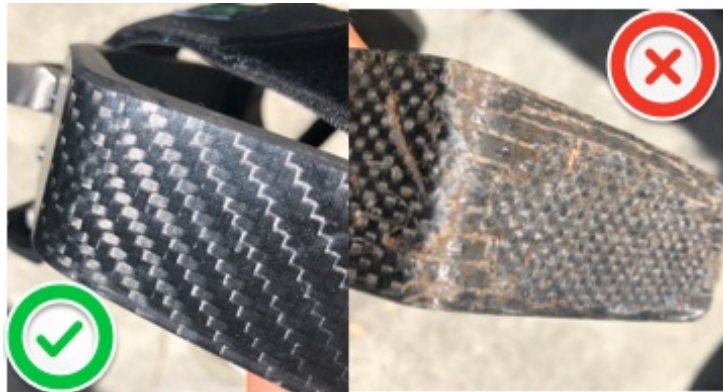
Stirrups:

- Have not started to delaminate especially at points marked in yellow. Testing shows typical failure @ 6Kn at time of manufacture.
- Check on bottom of stirrup. If layer of double bias is partially missing they no longer carry the original integrity at time of manufacture and are prone to delamination & failure.

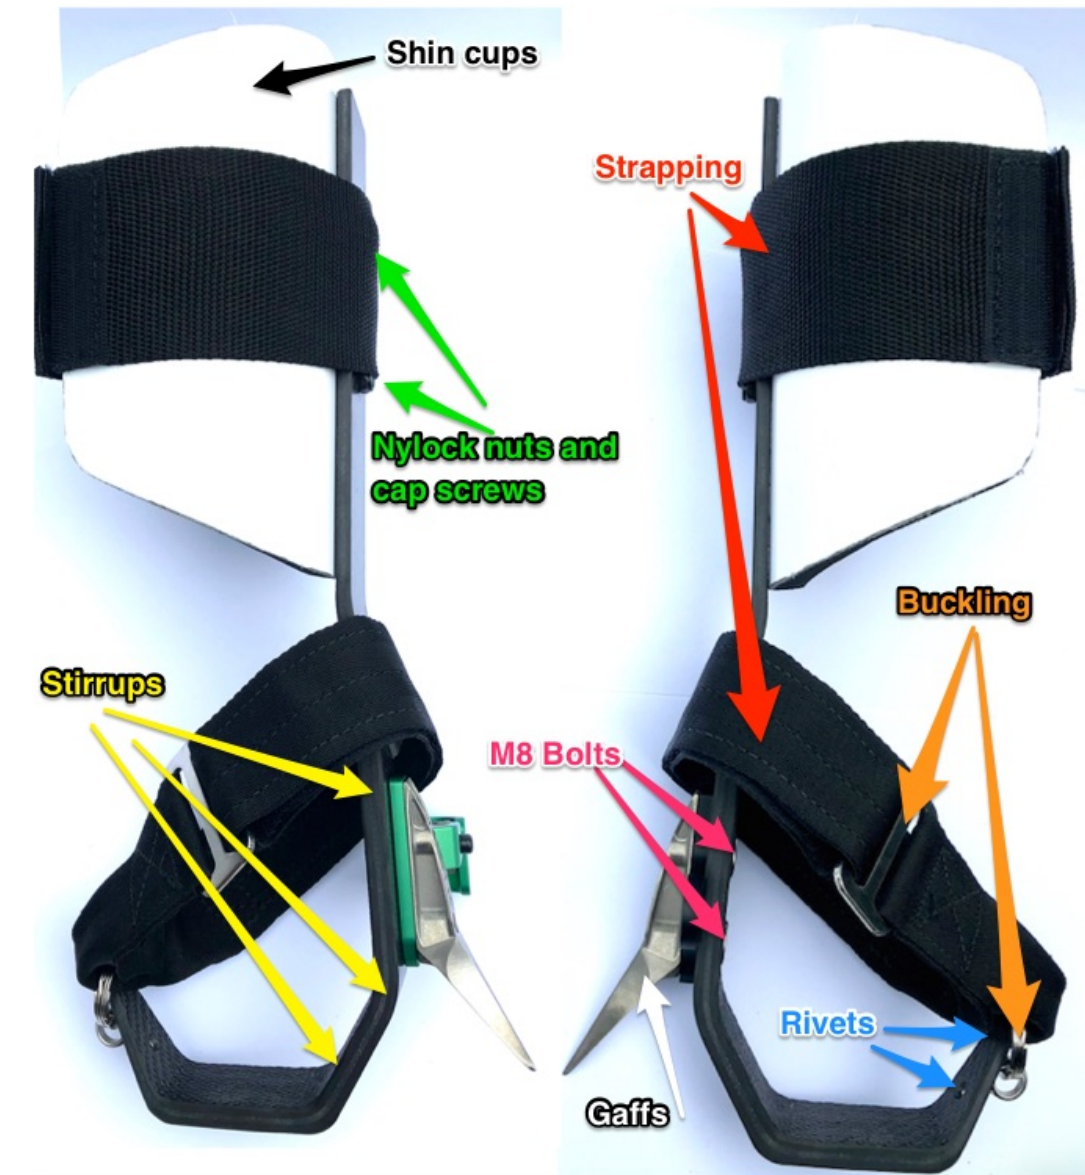
Bucklings & Rivets: Have not moved, not fractured / bent, different from original shape or excessively worn.

M8 Bolts: Are tight. Have not moved, not fractured / bent, different from original shape or excessively worn.

If any part doesn't pass a visual and physical inspection discontinue use
